Transportation Safety Board
of Canada

MARINE INVESTIGATION REPORT
M13N0014

CAPSIZING OF TOW AND ACCIDENTAL DEATH
TUG WESTERN TUGGER AND BARGE ARCTIC LIFT I
33 NAUTICAL MILES SOUTHWEST OF BURGIO,
NEWFOUNDLAND AND LABRADOR
10 MAY 2013

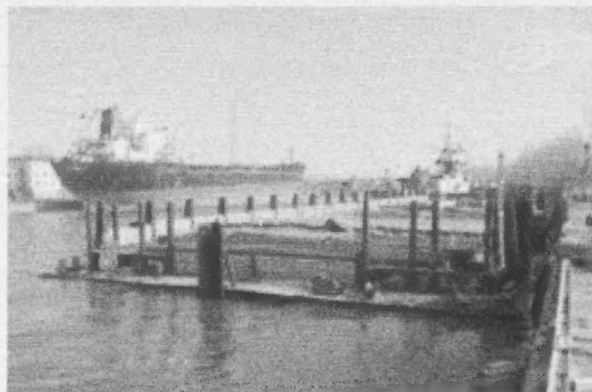
Photo 1. The *Arctic Lift I*, before departure from Sorel, Quebec

The barge *Arctic Lift I*, constructed of welded steel, was built in 1972 in the US (Photo 1). At the time, as per US regulations, it was assigned a load line² by the American Bureau of Shipping. The vessel was sold to a Canadian owner and began operating in Canada in 1998. The current owner purchased and salvaged the barge after a previous occurrence had left it a constructive total loss in 2006.

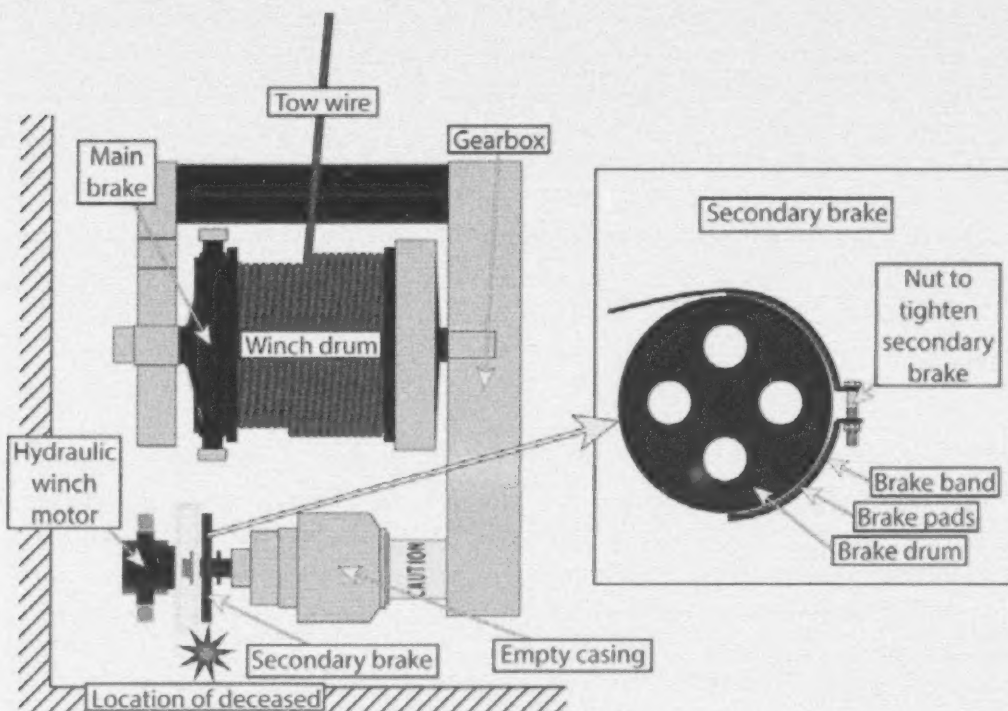
Figure 1. Simplified diagram of the towing winch, showing the locations of the 2 brakes and the nut used to tighten the secondary brake.

The tug had an emergency tow release that was intended to allow an operator located in the wheelhouse to immediately release both air brakes; however, this function was overridden by the nut-and-bolt assembly on the secondary brake.

On the *Western Tugger*, the main brake was unable to keep the winch drum from slipping while towing, even with the on-board practice of keeping the drum clutched in to the motor. For this reason, a secondary brake, which consisted of a brake drum on the drive shaft, had been

installed.⁵ However, these 2 brakes combined were still unable to keep the winch drum from slipping, so the on-board practice was to manually tighten the nut-and-bolt assembly on the brake band of the secondary brake in order to stop the winch drum from slipping.

Although the vessel had an emergency tow release, it could not be activated from the wheelhouse due to the nut-and-bolt assembly on the secondary brake. As such, the master requested that the deckhand go to the winch room and stand by to loosen the nut. Moments later, the forward end of the barge rose out of the water and the barge capsized. The resulting strain on the secondary brake drum caused it to shatter, and parts of it hit and fatally injured the deckhand.

The remote release on the *Western Tugger* was unable to function as intended because of the nut-and-bolt assembly on the secondary brake drum. The installation of a nut-and-bolt assembly required a crew member to enter the winch room and manually loosen the nut before the winch drum would pay out the tow wire, rendering the emergency tow release ineffective. This practice introduced a hazard to operations, which was not identified or mitigated.

The vessel operator is repairing the vessel's towing winch, which will not incorporate a second brake.

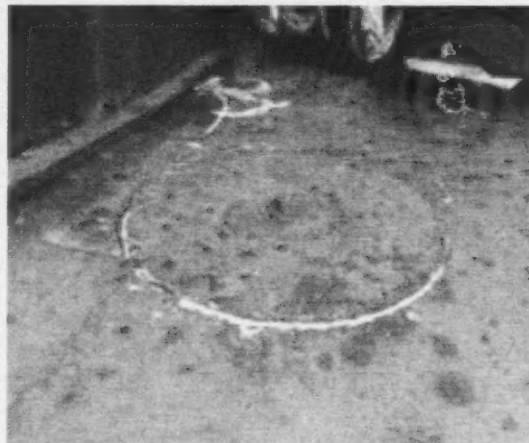
Photo 3. Silicon sealant on 1 of the 26 hatch covers

Prior to loading the cargo for this voyage, the barge owner visually inspected the seals on the hatches. A bead of silicon was applied around selected hatch covers where the previously applied sealant had deteriorated (Photo 3).

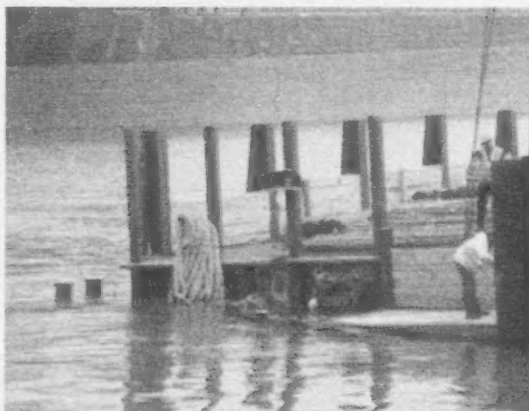
Photo 4. After end of barge during loading

Loading commenced on 29 April and involved fitting the bundled rebar of various lengths on the barge deck such that it was tightly and evenly packed. To keep the barge stabilized during loading, water was pumped in and out of tanks on the starboard side as required (Photo 4). The barge was loaded to a total weight of 7135 tonnes, a point at which the master and owner considered there to be adequate remaining freeboard and acceptable trim. Because the rebar was tightly packed to prevent movement, no lashings were used to secure it in place. When loading was complete, tarps were fastened over the cargo to protect it from the elements.

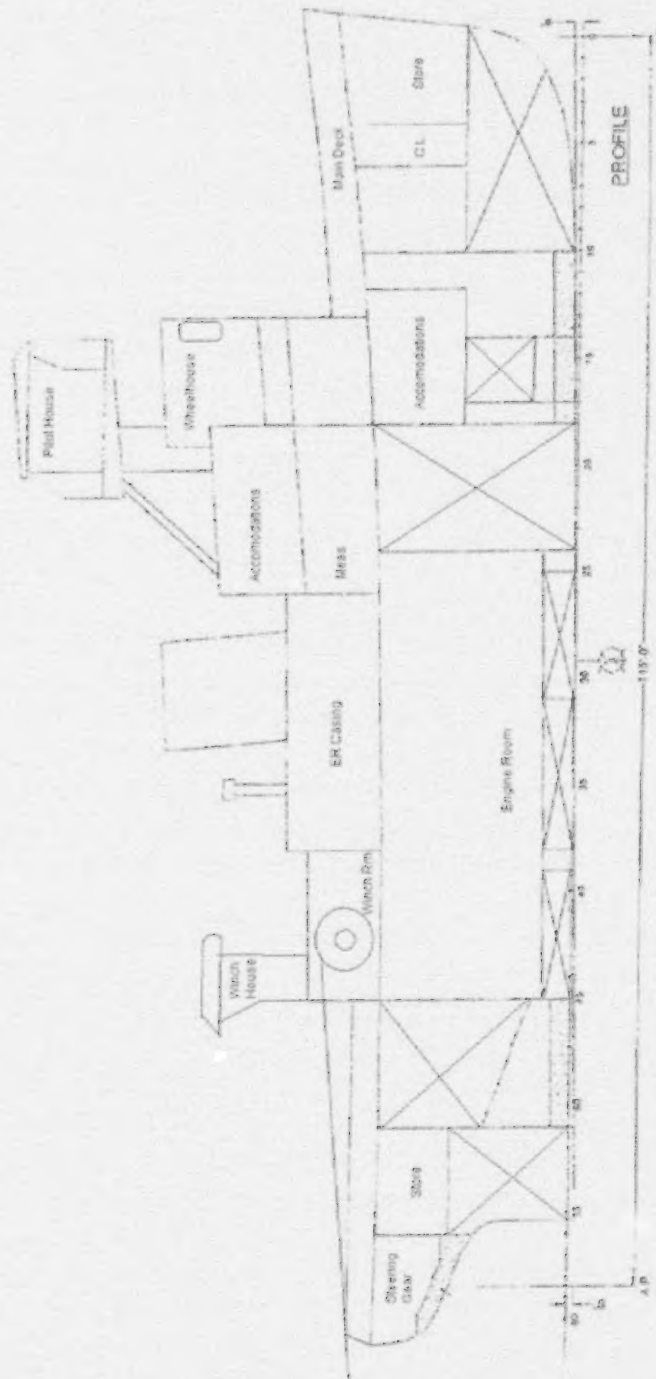
Appendix B - Profile of the Western Tugger

The towing winch is located in a winch room that is aft of the deckhouse on the main deck (Appendix B). The winch is operated from a winch house located directly above the winch room.³ The towing wire on the winch at the time of the occurrence was 460 m long and 5.08 cm in diameter. The towing winch itself was equipped with a main air brake on the steel winch drum and a secondary air brake on the drive shaft (Figure 1). Because the winch drum had a tendency to slip while towing, even with both brakes applied, a nut-and-bolt assembly on the secondary brake was used to tighten the brake band and hold the winch drum in place. When

When the secondary brake drum on the *Western Tugger* shattered, shards from the drum holed the deckhead and damaged the remote shut-off for the vessel's carbon dioxide extinguishing system. The shards also made dents and punctures in the winch room forward bulkhead and deckhead.
